NASA Technical Memorandum 104627

Degradation of FEP Thermal Control Materials Returned from the Hubble Space Telescope

DECEMBER 1995

Goddard Space Flight Center
Greenbelt, Maryland 20771

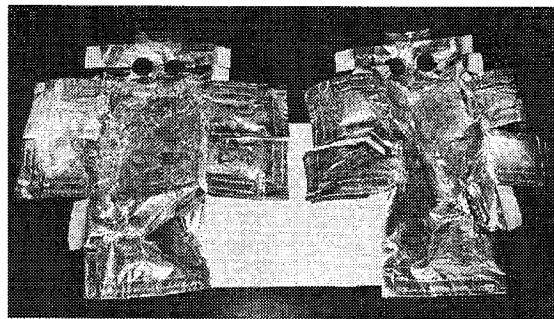
Figure 3: The returned magnetometer MLI assemblies. The thermal blankets are roughly 35 cm x 38 cm in size. The holes in the upper portion of the blankets are for cable access.

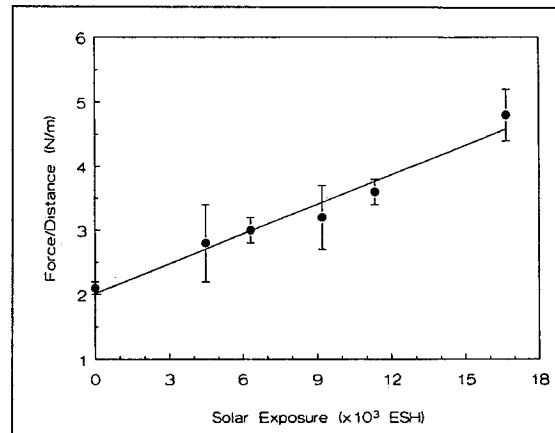
Figure 14 shows preliminary results of AFM microhardness results for magnetometer MLI samples with various solar exposures. In this graph the force per distance ratio was plotted versus solar exposure. Because it is not known from which MSS unit the MLI pieces were removed, the data for 6,324 ESH and 9,193 ESH may be switched in this graph. As can be seen, there is an increase in surface hardness of FEP with increasing solar exposure. This hardness increase is believed to be primarily due to UV induced cross-linking of the FEP, which causes polymer embrittlement.

Figure 14: AFM microhardness results of the magnetometer MLI samples.

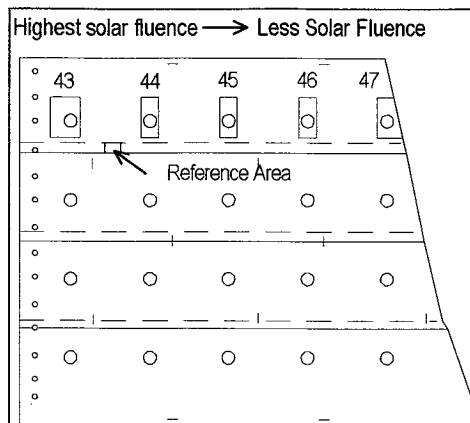
Figure 18: SA-I MLI thickness sample sectioning diagram. Samples 43-47 were taken to examine the material thickness as a function of varying amount of solar exposure. The reference sample was taken from underneath an overlapping piece of FEP, and was not directly exposed to the space environment.
